Printable View (18 KB)	
TSB 04-15-6	<ul style="list-style-type: none"> • TR3650 MANUAL TRANSMISSION - JUMPS OUT OF GEAR 2ND AND/OR 3RD - CLASH NOISE AND/OR RASPY FEEL ON GEAR ENGAGEMENT
Publication Date: July 20, 2004

FORD: 2001-2003 Mustang

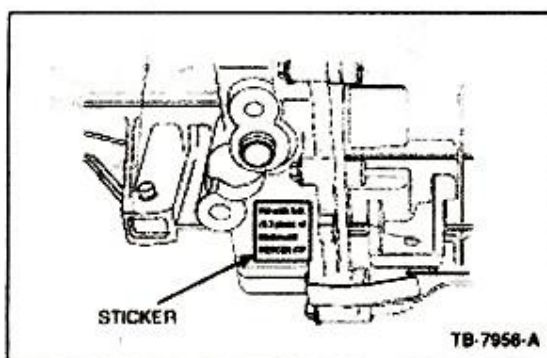
Figure 1 - Article 04-15-6

1. Remove the transmission from the vehicle.
2. Disassemble the transmission.
3. Install all of the revised components included in kit 3R3Z-7124-AC.
4. Clean oil from area 26 mm (1") below the transmission fill plug (Figure 1) and install the oil fill sticker included in the kit.

5. Reinstall the transmission.
6. Fill the transmission with 3.0 liters (6.3 pints) of Motorcraft Mercon ATF (XT-2-QDX). The full fill level is approximately 19 mm (0.75") below the fill hole.
